ВОЗДЕЙСТВИЕ ВОЛН ЦУНАМИ НА ПОБЕРЕЖЬЕ И СООРУЖЕНИЯ

TSUNAMI ACTION ON COASTS AND CONSTRUCTIONS

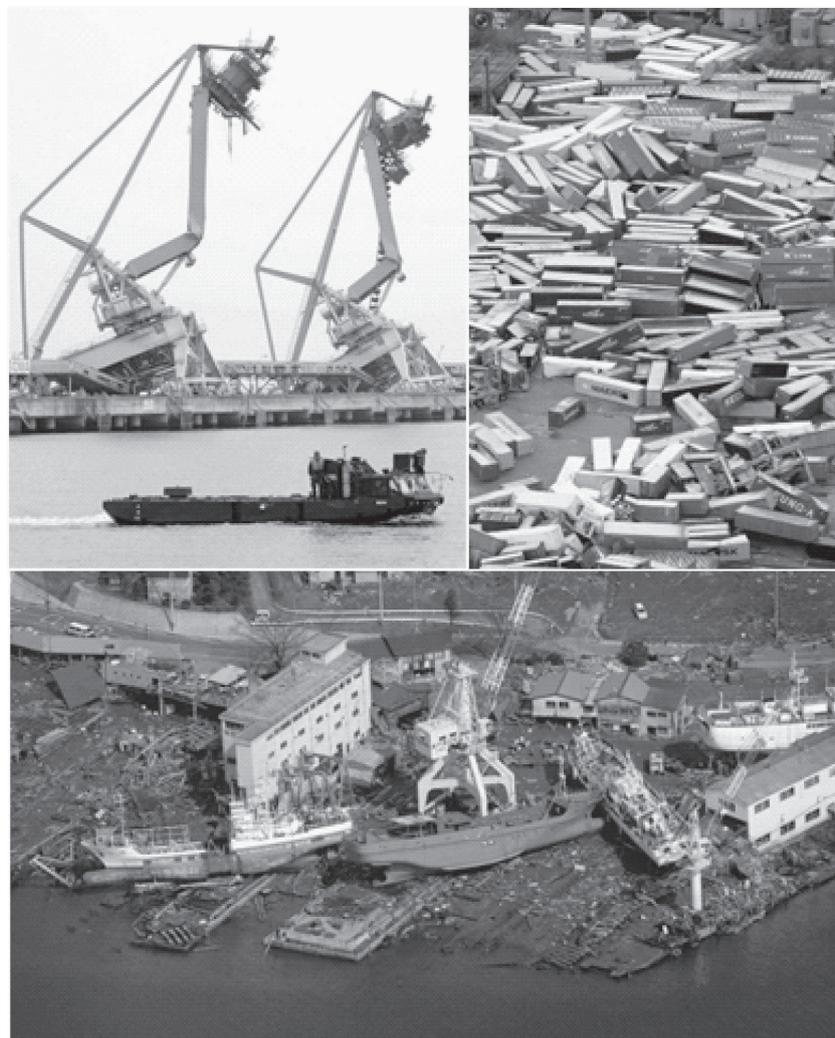
Fig. 3. The damage to the Port of Sendai caused by the Great Tohoku, Japan Earthquake and Tsunami in March 2011.

Рис. 3. Повреждение Порта Сендая, вызванного Большим Землетрясением и Цунами в марте 2011.

«Many dock warehouses and loading machines were inundated and destroyed. Containers and cars were washed away to the sea» [7] — all these contributed to increased and extensive damage in harbors and ports. The Great East Japan Earthquake and Tsunami (2011) caused severe damages to ports and harbors along the Pacific coast. Fig. 3 clearly shows the extent of damage to the Sendai Port, Japan. In the Kamaishi Port the GEJE tsunami dumped a cargo ship of 175,000 tons on top of a pier (Fig. 4, *a*) and eroded ground around the concrete building is also shown in Fig. 4, *b*. The reader is advised to refer to [7] for a detailed coverage of damages to Japanese ports due to the Great East Japan Earthquake and Tsunami (2011).

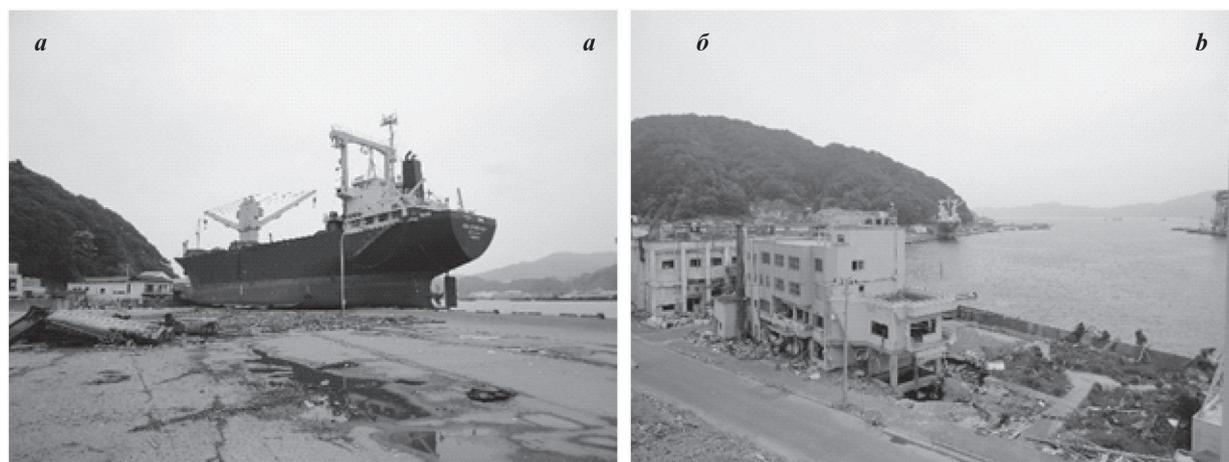
Fig. 4. A cargo ship dumped to a pier in the Kamaishi Port, Japan (a) and the scour around concrete building in Kamaishi by the Great East Japan Earthquake and Tsunami (b) (photos by Ahmet Cevdet Yalciner).

Рис. 4. Грузовое судно, сваленное к пирсу в Порту Камаиши, Япония (a) и разрушения вокруг бетонного здания в Камаиши Большим Восточным Землетрясением Японии и Цунами (b) (фотографии Ахмета Ялченира).

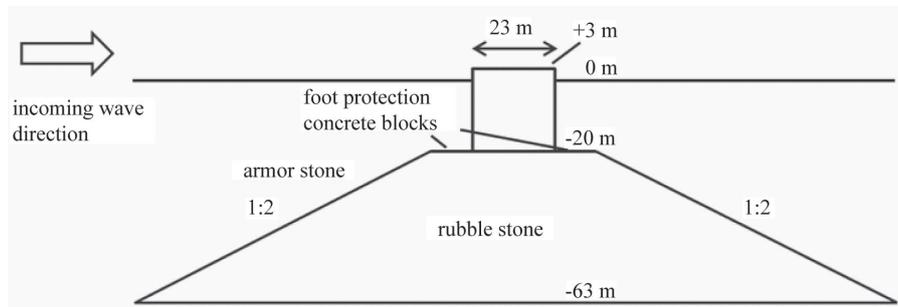
Fig. 5. Cross-section through the Kamaishi South breakwater [10].

Рис. 5. Поперечное сечение через волнорез Юга Камаиши [10].

8500 m of breakwaters including dedicated tsunami breakwaters like the World record breakwater at Kamaishi collapsed during the 2011 tsunami [8]. It was constructed in a maximum water depth of 63 m consisting of two sections: one, 670 m length and the other 770 m length. A cross-section is indicated in Fig. 5.

The failure of the breakwater has been investigated using physical and numerical modelling performed by the Port and Airport Research Institute (PARI).

The investigation showed that the failure of breakwater was due to three effects caused by the tsunami overflow. One, water level difference between the two sides of the breakwater resulted in a rise in the lateral force, two, the overflow scouring causing a decline in friction between the caisson and mound leading to sliding [9], and three the seepage between the blocks (50 cm distance) causing additional scouring of the back fill materials.

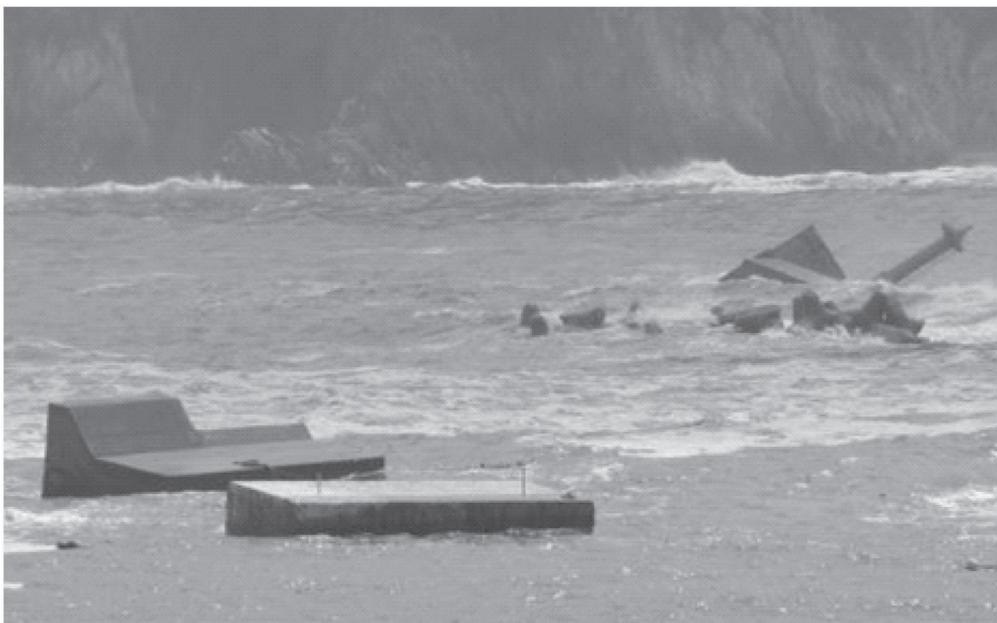
Fig. 6. A variety of concrete debris from breakwater and seawalls offshore of Tarō which observed during the 2011 EEFIT mission [3].

Рис. 6. Множество бетонных обломков от волнореза и дамб на расстоянии от берега Tarō, которые обследовались во время полевых исследований 2011 г. [3].

Fig. 6 shows a variety of concrete debris which were the parts of breakwater and seawall in the bay of Tarō. The picture was taken during the 2011 EEFIT survey. Clear effects of scour on the sea dikes is indicated in Fig. 7 where effects of scour on the lee side causing to insufficient cracking of reinforced concrete lattice work.

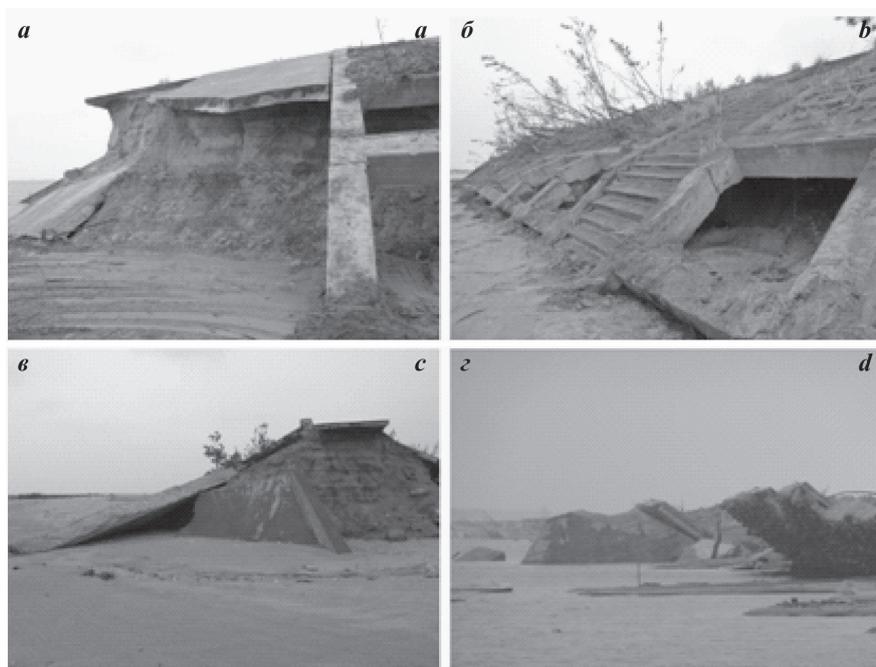
Fig. 7. Failure of Yamamoto sea dikes, captured during the 2011 EEFIT mission.
a — exposed sand core on the lee side; *б* — proof of sand core having been washed out;
в — exposed section through the sea dike; *г* — debris of the dike at the distance, lying in pools of seawater to the lee side of the structure having not subsequently drained away [3].

Рис. 7. Фото прорыва морских плотин Ямамото, обнаруженных во время полевых исследований EEFIT 2011 г.

a — размывте песковой основы; *б* — размывте песковой основы с другой стороны;
в — разрушение секции морской дамбы; *г* — разрушение плотины [3].

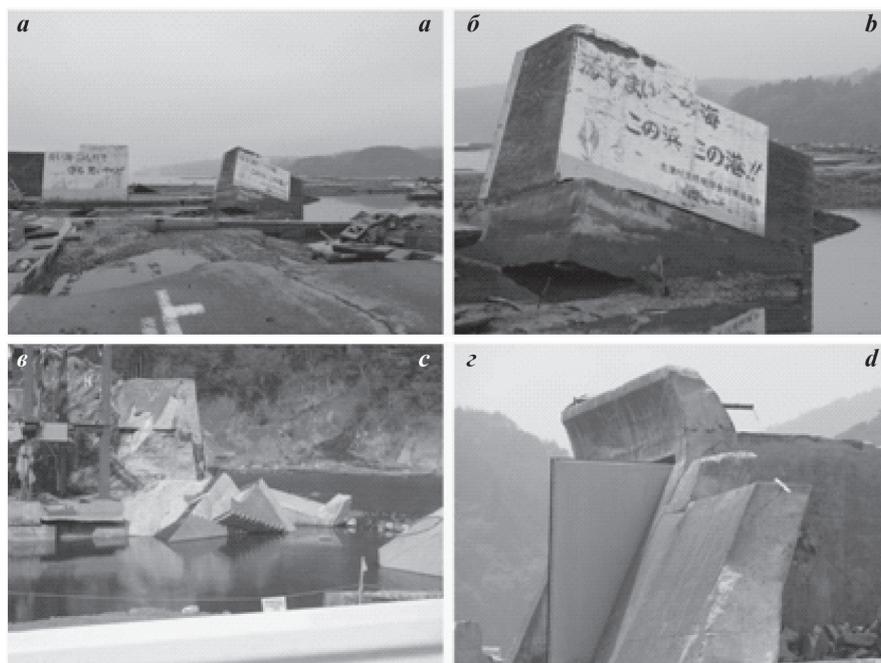
Fig. 8. Damage to the seawall observed during the 2011 EEFIT Mission.
a — failure of seawall and quay at Minamisanriku; *б* — close-up of seawall block at Minamisanriku indicating no interlinkages;
в — restoration of the seawall at Miyako Bay; *г* — remaining seawall buttress at Tarō [3].

Рис. 8. Повреждение дамбы, наблюдаемой во время полевых обследований 2011 г.

a — дамба и причал в Минамисанрику; *б* — дамба в Минамисанрику;
в — дамба в заливе Мияко; *г* — оставшаяся часть дамбы в Тарō [3].

Seawall failures of both gravity seawalls and compacted sand core structures were also observed (Fig. 8). Failure mechanisms of the Tarō seawall included the removal of rear slope protection blocks due to the tsunami overflow, the collapse of the crest parapet due to impulsive fluid forces, the collapse of the front protection blocks due to draw-down and there was also evidence of shear failure between blocks [11].

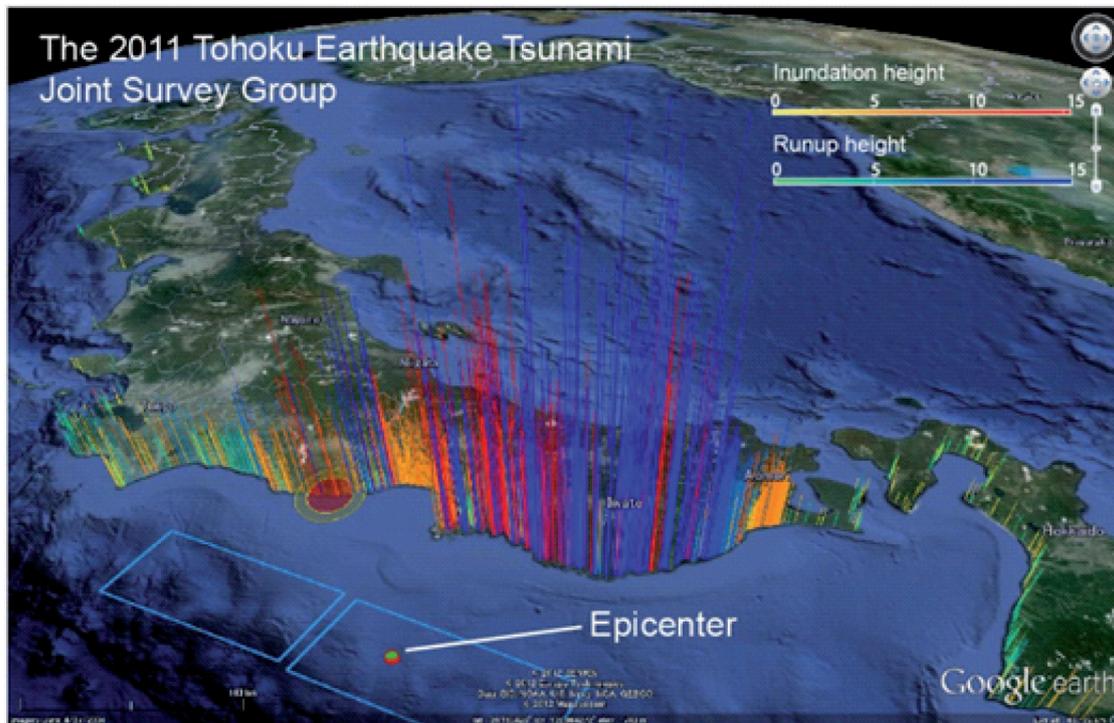
Fig. 1. 11 March 2011 Tohoku earthquake and tsunami.
After the 2011 Tohoku Earthquake Tsunami Joint Survey (TTJS) Group.

Рис. 1. 11 марта 2011 г. Тохоку землетрясение и цунами.
Полевые обследования Цунами Землетрясения Тохоку 2011 г. (TTJS).

The Great East Japan Earthquake (GEJE) was the fourth most powerful earthquake recorded in the past 100 years. The quake shock last for six minutes. A half hour later, a massive tsunami penetrated over 650 km of coastline (Fig. 1, see the insert), overtopping sea walls and other coastal defence structures, flooding through more than 500 km² of land causing entire towns and villages to be washed away. Japan was simply not as prepared as they estimated they were for such a disaster, e.g., causing 15,883 fatalities and 2,654 missing in northeastern Japan [4] and damage costs of \$150 billion. The Fukushima, Iwate, and Miyagi prefectures were the worst hit areas.
